Peace Of Mind Home Inspections

1234 Sample St. Quiet Town, MN

Prepared for: **Mr and Mrs Valued Client**

Prepared by: **Peace of Mind Home Inspections**

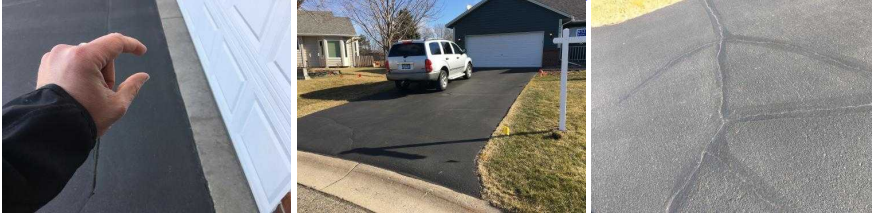
1. Marginal Driveway: Asphalt - Cracks and settlement noted. Recommend filling cracks and sealing driveway as regular maintenance every 2- 4 years

1. Driveway: Asphalt - Cracks and settlement noted. Recommend filling cracks and sealing driveway as regular maintenance every 2- 4 years

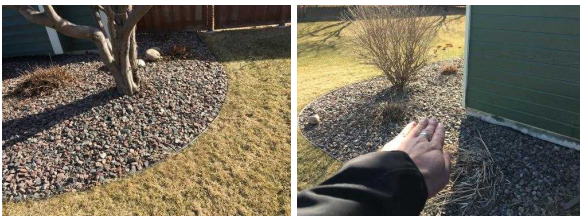
5. Marginal Grading: Minor slope / Flat - The grading is flat in some spots (front and rear corners) around the home and the soil should be increased to the proper slope so that water can flow away from the home as needed.

2. Grading: Minor slope / Flat - The grading is flat in some spots (front and rear corners) around the home and the soil should be increased to the proper slope so that water can flow away from the home as needed.

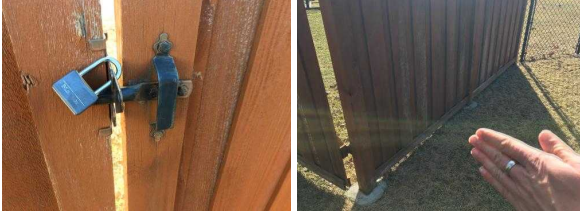
8. Marginal Fences: Wood - Recommend staining wood and checking posts as regular maintenance.

3. Fences: Wood - Recommend staining wood and checking posts as regular maintenance.

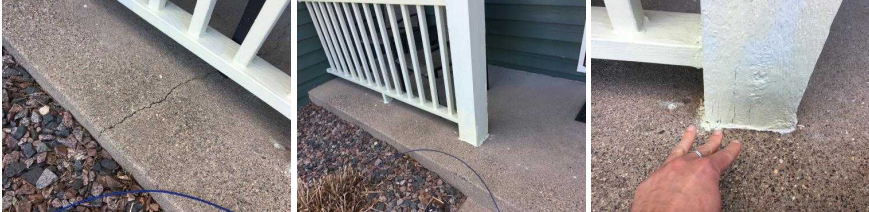
9. Marginal Porch: Concrete - Recommend patching crack. Deterioration at the base of post.

4. Porch: Concrete - Recommend patching crack. Deterioration at the base of post.

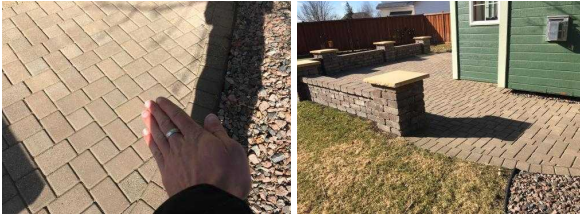
10. Acceptable Patio: Paver - By spreading paver locking sand across the bricks/blocks and sweeping it over the entire surface will fill in the crevasses and help with water shed and plant life reduction.

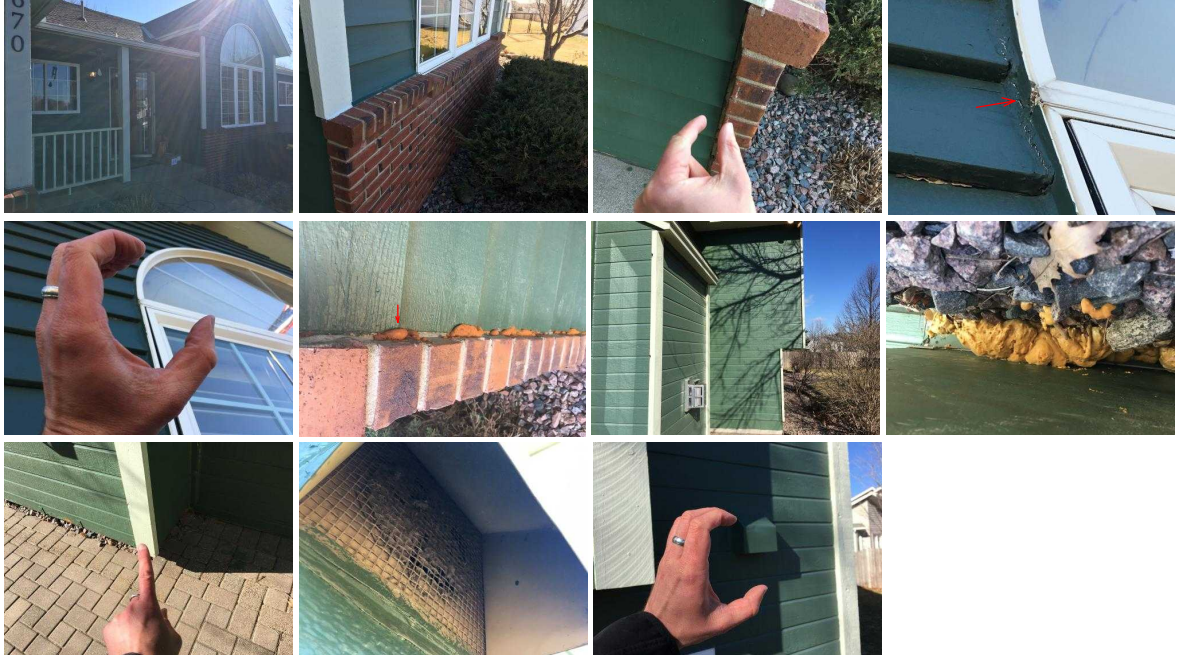
Type: (continued)

1. Marginal Type: Wood and Brick - Gaps at trim near front window should be caulked. brick fronts have minor separation recommend patching gaps and monitoring. spray foam has been added under the fireplace bump out. May have a gaps that was filled. Recommend cleaning the air intake vent for fresh air to utility room.

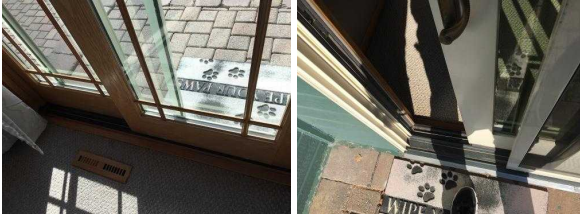
8. Acceptable Patio Door: Wood sliding

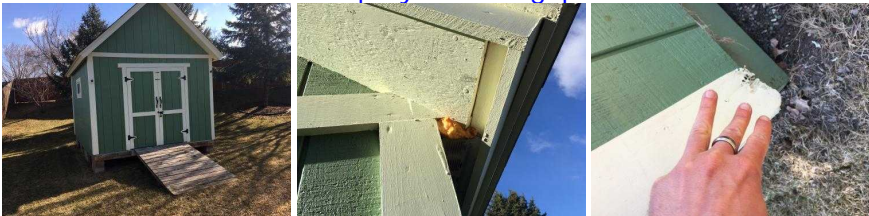
1. Marginal Exterior Surface: Wood - [Spray foamed gaps at soffit.](#) [Deteriorated trim](#)

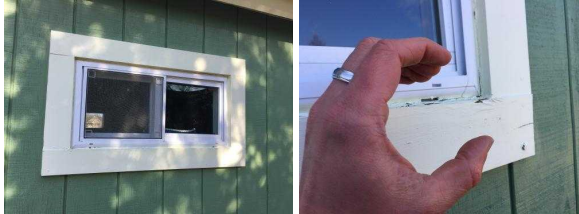
7. Not Inspected, Marginal Windows: Vinyl slider - [Recommend repairing peeling paint and caulking connections](#)

11. Rear Outbuilding Windows: Vinyl slider - [Recommend repairing peeling paint and caulking connections](#)

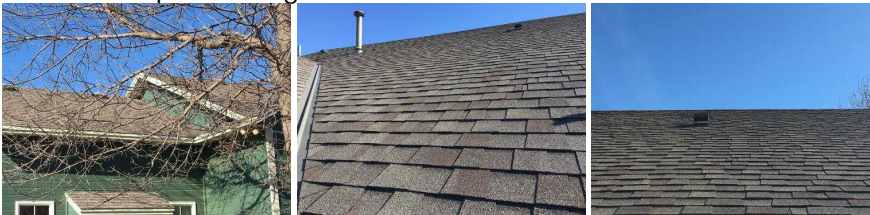
3. Acceptable Material: Asphalt shingle

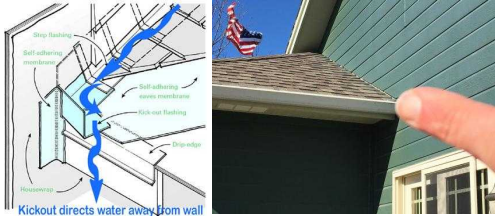
6. Acceptable Flashing: Galvanized - Flashings under siding or roofing is not inspected. Recommend kick out flashings at base of roof to wall connections. Kick out flashings have become common on new construction. They were not common with older homes. These flashings direct water away from the wall along the roof line. We highly recommend these. They are most commonly added when roofing is redone.

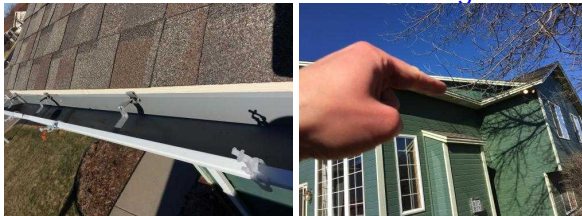
10. Not Present Electrical Mast:
11. Marginal Gutters: Aluminum - Recommend gutters in rear.

12. Gutters: Aluminum - [Recommend gutters in rear.](#)

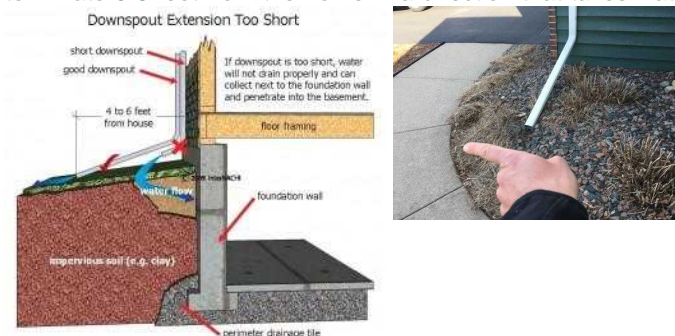
12. Acceptable Downspouts: Aluminum
13. Acceptable Leader/Extension: Attached - Recommend gutter is directed onto the driveway. Extensions should always terminate 6-8 feet from the home in a direction that takes water downhill away from home.

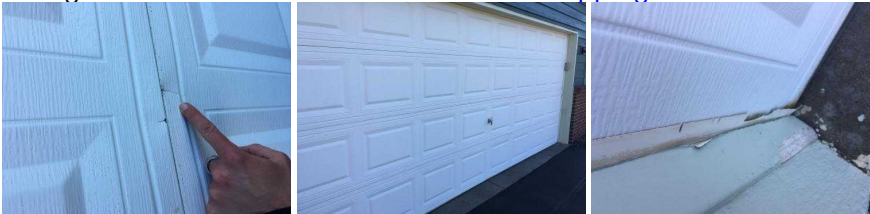
2. Marginal Garage Doors: Metal - [Dented. Weather stripping torn.](#)

13. Attached Garage Garage Doors: Metal - [Dented. Weather stripping torn.](#)

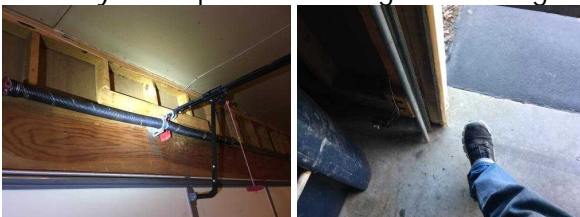
3. Acceptable Door Operation: Mechanized - Recommend using white lithium grease on springs and rollers once a year to prevent rusting and seizing which can crack overhead springs.

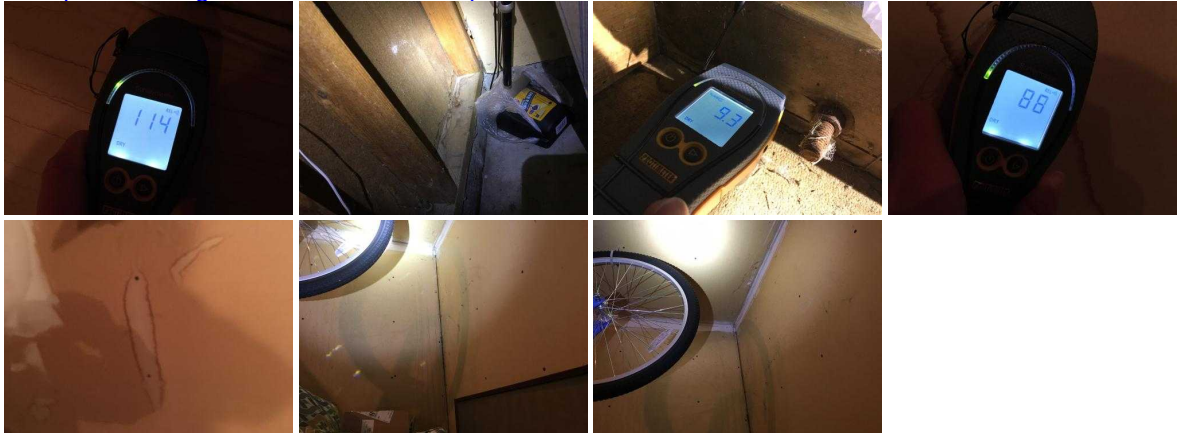
7. Marginal Walls: Fire Rated Drywall - All drywall that is part of the fire barrier should have any gaps or holes patched to maintain a proper fire barrier. Moisture levels of stained areas were within acceptable ranges at the time of inspection.

14. Attached Garage Walls: Fire Rated Drywall - [All drywall that is part of the fire barrier should have any gaps or holes patched to maintain a proper fire barrier. Moisture levels of stained areas were within acceptable ranges at the time of inspection.](#)

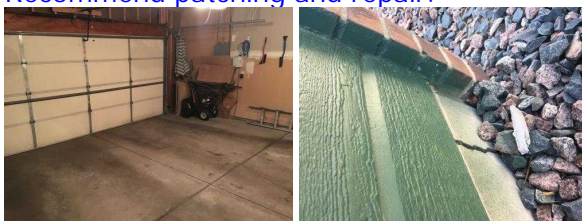
9. Marginal Floor/Foundation: Poured slab - Pitting observed. Crack at corner of block foundation near door. Recommend patching and repair.

15. Attached Garage Floor/Foundation: Poured slab - **Pitting observed. Crack at corner of block foundation near door. Recommend patching and repair.**

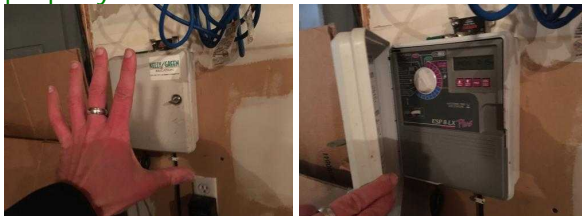
11. Not Inspected Lawn Sprinklers: Front and back yard - Not tested due to season, as the sprinkler system is still shut down therefore it was not inspected. Recommend checking with sellers that the system was properly winterized.

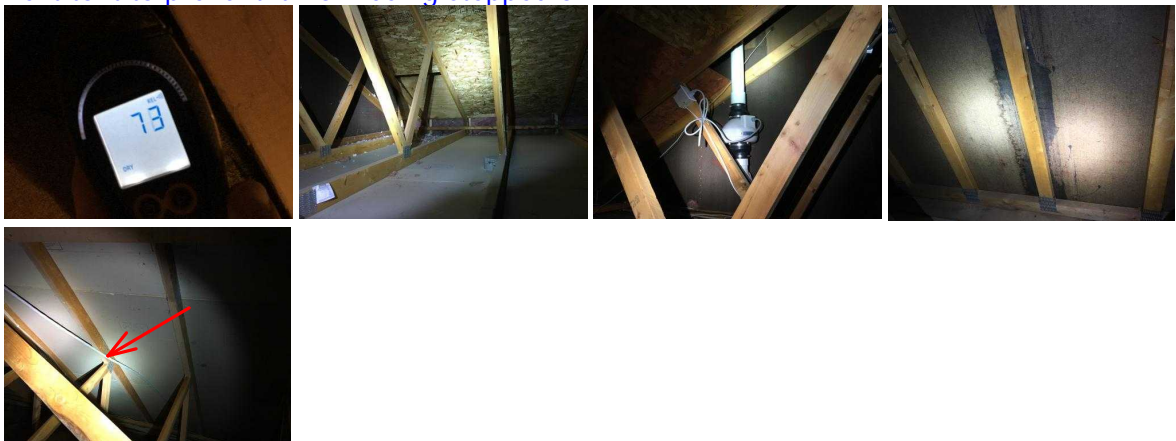
13. Marginal Roof Structure: 2x4 Truss - Staining noted on the front wall. Tested within acceptable ranges at the time of inspection. loose wire across framing should be secured. Recommend adding 2x4 next to it to prevent it from being stepped on.

16. Attached Garage Roof Structure: 2x4 Truss - **Staining noted on the front wall. Tested within acceptable ranges at the time of inspection. loose wire across framing should be secured. Recommend adding 2x4 next to it to prevent it from being stepped on.**

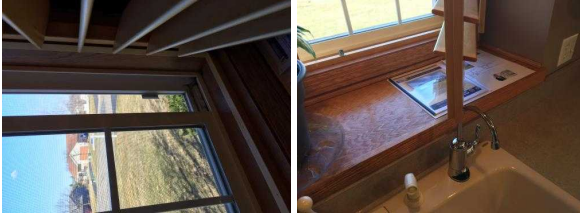
Windows: Vinyl slider - The shutters hit the RO water dispenser and cannot be fully opened.

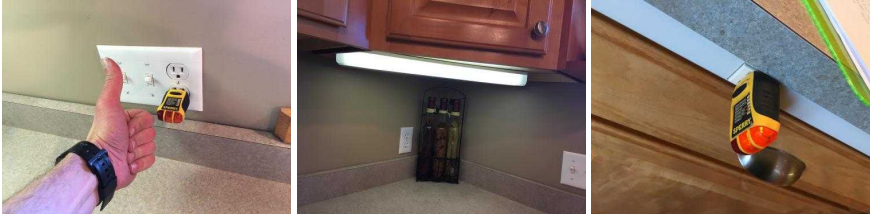
Counter Tops: Laminate
Cabinets: Wood
Pantry: Single
Electrical: 110 VAC GFCI

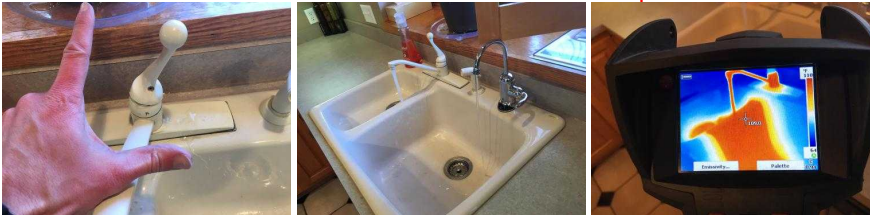
Sink: Stainless Steel - Faucet head leaks in rear position.

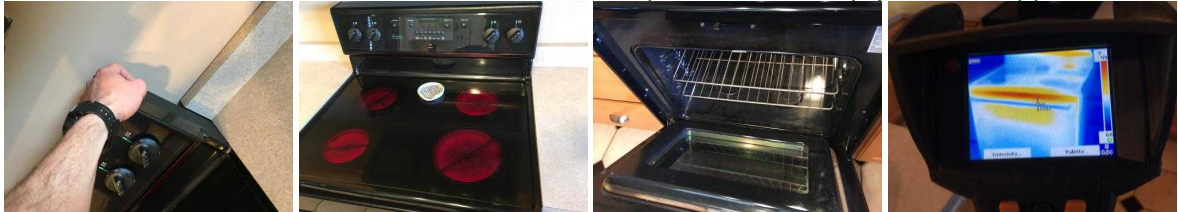
Cooking Appliances: The cooking appliances were tested. Ovens are warmed but not brought up to full temp to avoid any ovens being left on while outside the room. This reduces chances of anything being accidentally left on after leaving. No anti tilt bracket observed. These are common on newer stoves and can sometimes be purchased cheaply at used appliance stores.

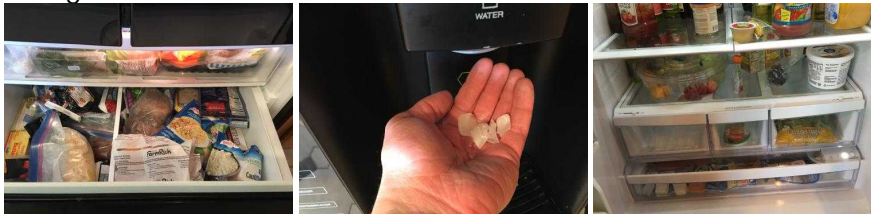
Refrigerator:

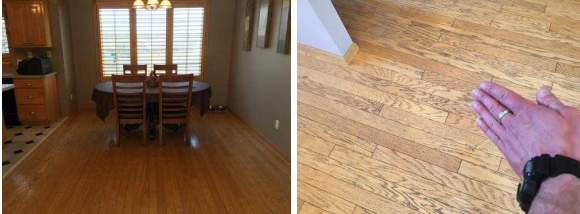
1. Acceptable Floor: Wood and Carpet - **Floor finish wear observed. Recommend refinishing.**

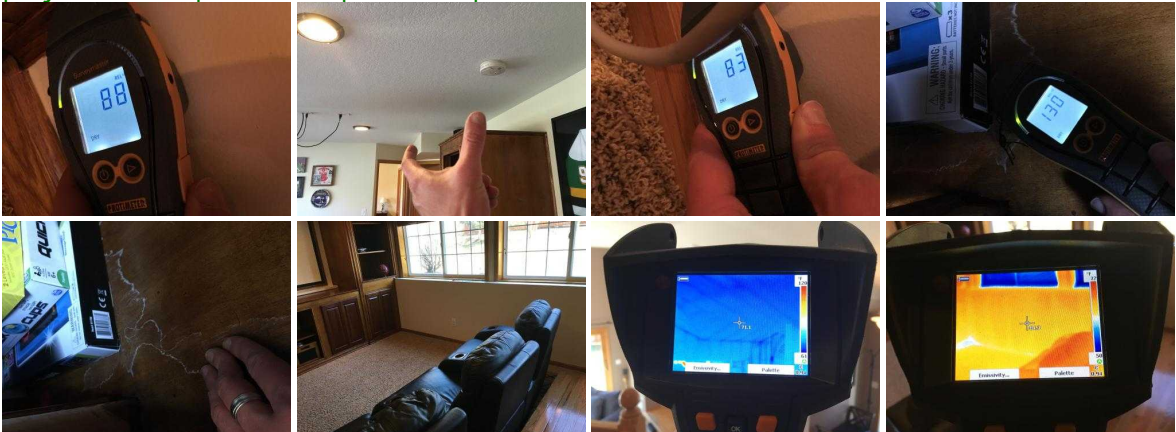
Walls: Paint - The exterior walls in the lower level were tested with the moisture meter and were within acceptable levels. They were also tested with the thermal camera which no signs of obvious water entry were observed at the time of the inspection. Staining noted in cabinets. Tested within acceptable levels. No plumbing is near this areas and may be from a spill. AV projector not operated as part of inspection

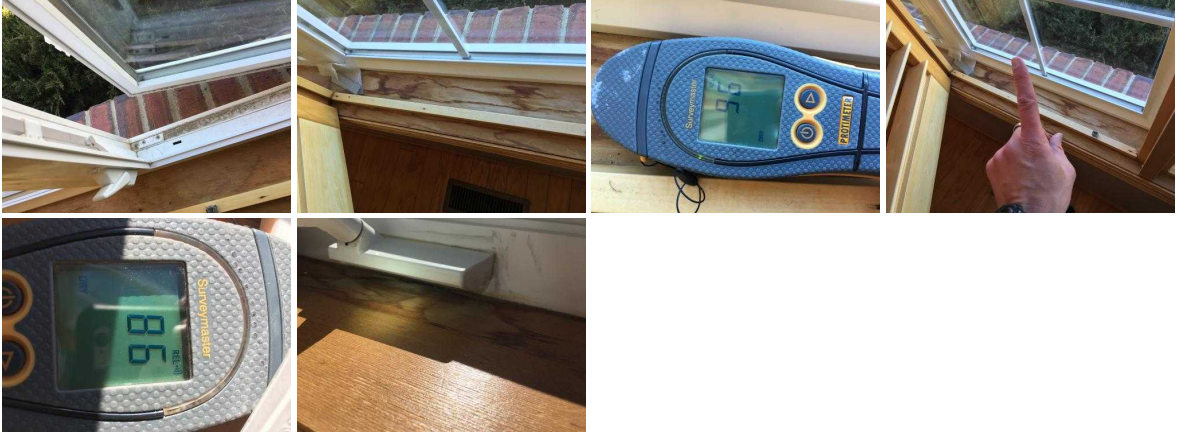
Windows: Vinyl Casement and Sliders - Staining noted on most window frames. These areas tested within acceptable ranges at the time of inspection. May be due to condensation or exterior seal / flashing. Recommend further investigation and caulking exterior connections.

18. All Living Areas Living Space Windows: Vinyl Casement and Sliders - Staining noted on most window frames. These areas tested within acceptable ranges at the time of inspection. May be due to condensation or exterior seal / flashing. Recommend further investigation and caulking exterior connections.

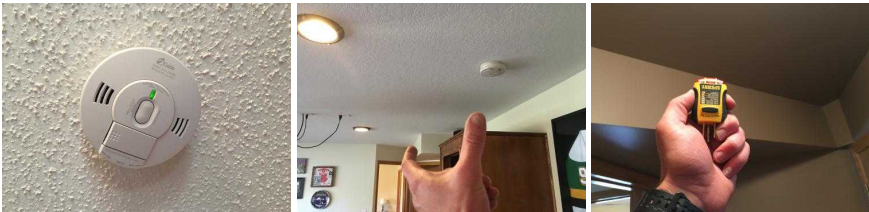
Smoke Detector: Battery operated - LL bedroom does not have a smoke detector within 10 feet. Recommend additional smoke detector.

19. All Living Areas Living Space Smoke Detector: Battery operated - LL bedroom does not have a smoke detector within 10 feet. Recommend additional smoke detector.

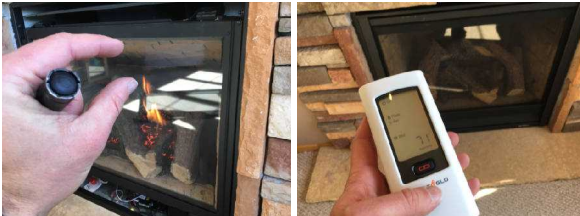
4. Marginal Fireplace Insert: With thermostatically controlled fan - **The fan was not responsive in the flame height was touching the top of the firebox. The remote did not turn on the fan through the standard operating sequence within a quick time frame. Recommend HVAC contractor tune and evaluate unit**

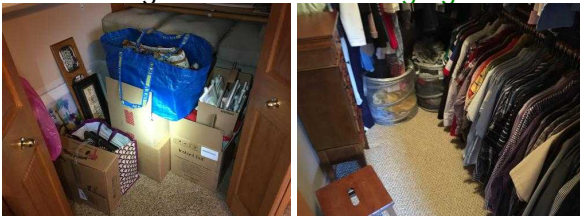
4. Acceptable Closet: Large - **Personal belongings limited view.**

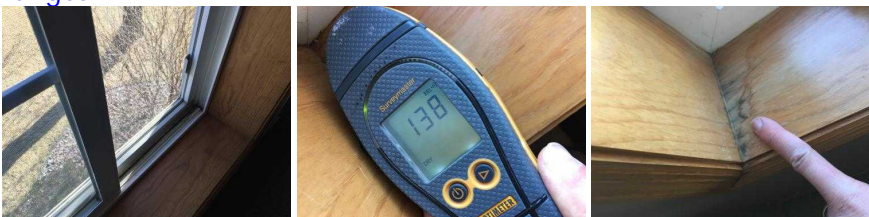
6. Marginal Windows: Vinyl Casement and Sliders - **Staining on trim in master tested within acceptable ranges.**

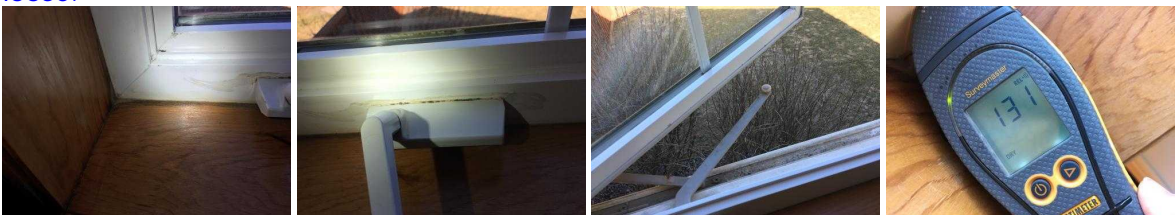
5. Marginal Windows: Vinyl casement - **Staining noted on trim. Tested within acceptable ranges. Arm was loose.**

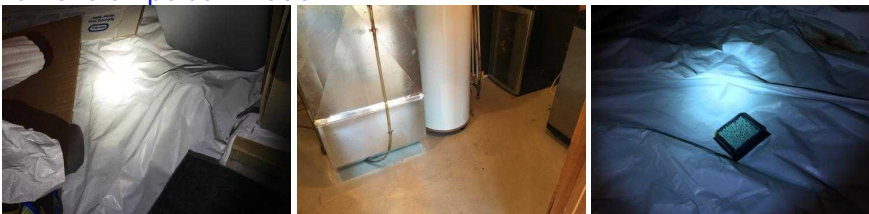
- 2. Acceptable Ceiling: Exposed framing
- 3. Acceptable Walls: Exposed framing
- 4. Marginal Floor: Poured and vapor barrier covered gravel. - [Mouse poison noted. Recommend seller remove all poison hidden.](#)

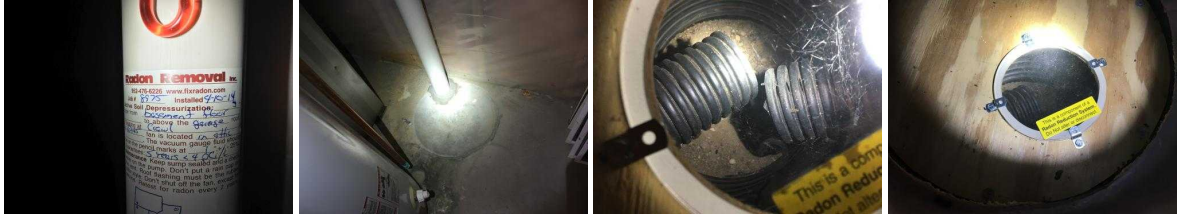
- 6. Acceptable Doors: Solid wood
- 7. Not Present Windows:
- 8. Acceptable Electrical: 110 VAC outlets and lighting circuits
- 9. Not Present Smoke Detector:
- 10. Acceptable Sump Pump: Pit was dry. Radon system appeared functional. Recommend caulking monometer on the radon reduction pipe in place.

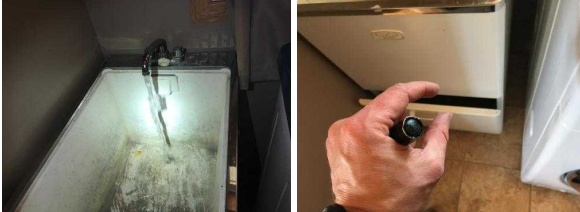
7. Acceptable HVAC Source: Heating system register
8. Marginal Laundry Tub: PVC - Springs on lower door are tired and not fully closing recommend adjustment / repair.

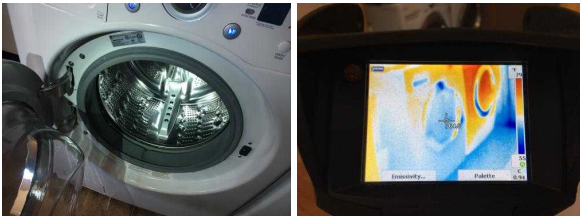
10. Acceptable Washer

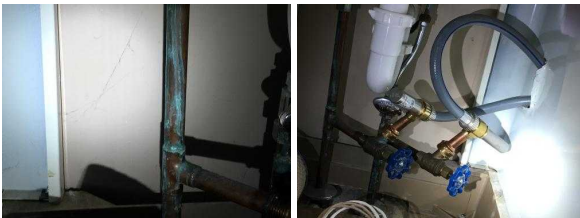
11. Marginal Washer Hose Bib: Gate valves - Corrosion noted. Recommend cleaning and monitoring. Standard rubber hoses while fully functional have a shorter life span. When the rubber dries out the hose can crack and bust causing flooding. Recommend steel braided lines to reduce the risks of hose bursts.

26. 1st Floor Laundry Room/Area Washer Hose Bib: Gate valves - [Corrosion noted. Recommend cleaning and monitoring. Standard rubber hoses while fully functional have a shorter life span. When the rubber dries out the hose can crack and bust causing flooding. Recommend steel braided lines to reduce the risks of hose bursts.](#)

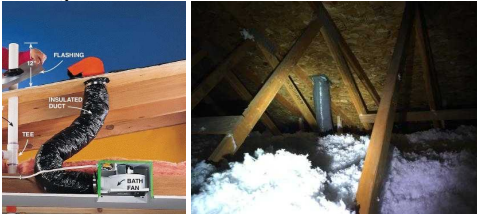
11. Acceptable Bathroom Fan Venting: Electric fan - Bathroom venting that is inside a wall or obscured / not easily viewed from view from the attic access are not inspected.

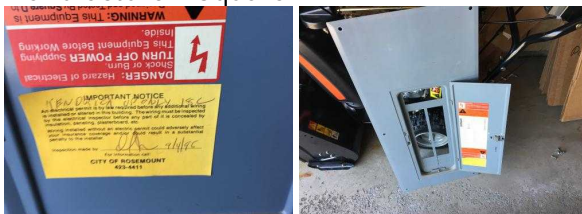
9. Acceptable Manufacturer: Square D

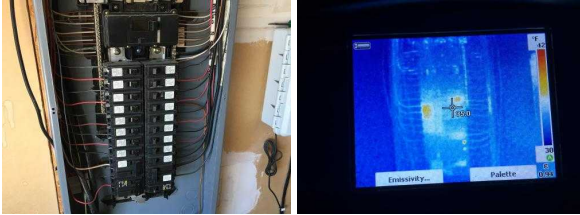
- 10. Maximum Capacity: 150 amps
- 11. Acceptable Main Breaker Size: 150 amps
- 12. Acceptable Breakers: Copper and Aluminum - Breakers were within acceptable temperature ranges at the time of inspection.

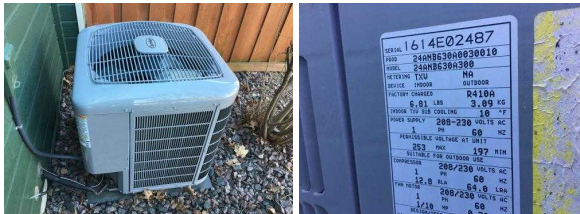
2. Acceptable Exterior Unit: Pad mounted

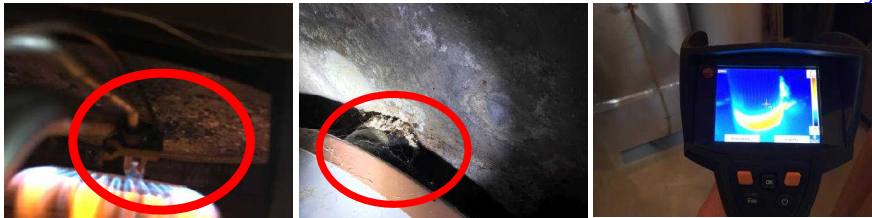
8. Marginal Water Heater Operation: Functional at time of inspection - Older unit. rust and scale noted. recommend planning for replacement. Manufacturers recommend (on new units) draining water softer annually to flush debris in the tank. Use caution and follow manufacturers instructions. Manufacturers estimate life of most units to be between 7 and 12 years

29. Basement Water Heater Water Heater Operation: Functional at time of inspection - Older unit. rust and scale noted. recommend planning for replacement. Manufacturers recommend (on new units) draining water softer annually to flush debris in the tank. Use caution and follow manufacturers instructions. Manufacturers estimate life of most units to be between 7 and 12 years

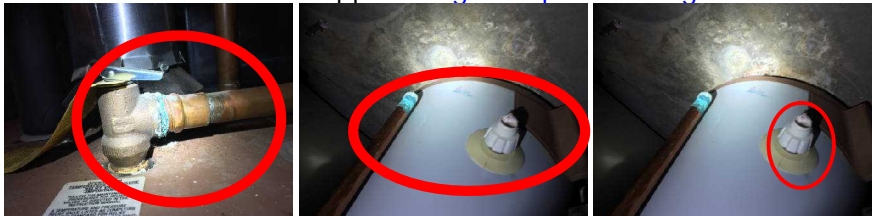
13. Defective TPRV and Drain Tube: Copper - signs of past leaking. drain is leaking

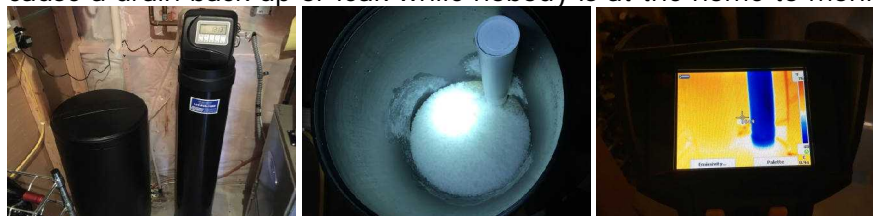
15. Acceptable, Not Inspected Water Softener Water softener appears functional. The unit was not tested or run through a full refresh cycle since this takes sometimes several hours which could cause a drain back up or leak while nobody is at the home to monitor.

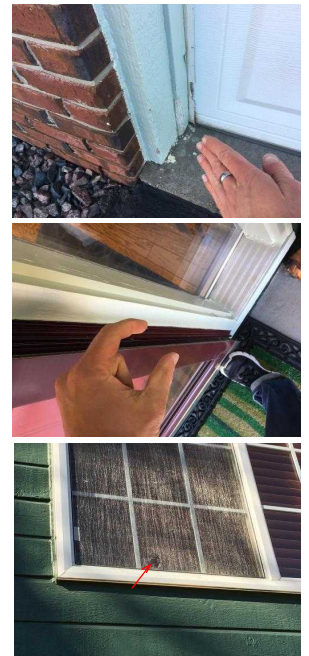
6. Trim: Wood - Chipped and peeling paint on trim. As annual maintenance any wood trim should be checked for cracked or chipped paint and if there is cracks or chips in the paint this should be repainted to prevent any possible moisture intrusion which could lead up to deterioration of the material.
7. Entry Doors: Metal - Front storm door needs adjustment / repair to close
8. Window Screens: Vinyl mesh - Torn Screen, Not all of the screens were in place. Recommend checking count at your walk through.

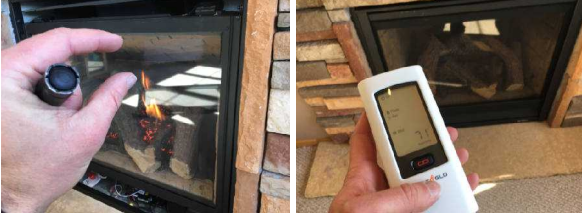
20. All Fireplace Fireplace Insert: With thermostatically controlled fan - The fan was not responsive in the flame height was touching the top of the firebox. The remote did not turn on the fan through the standard operating sequence within a quick time frame. Recommend HVAC contractor tune and evaluate unit

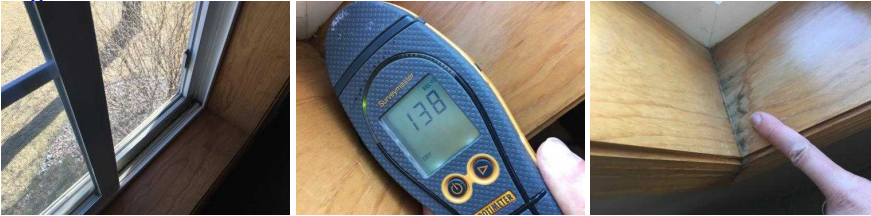
21. All Bedroom Windows: Vinyl Casement and Sliders - [Staining on trim in master tested within acceptable ranges.](#)

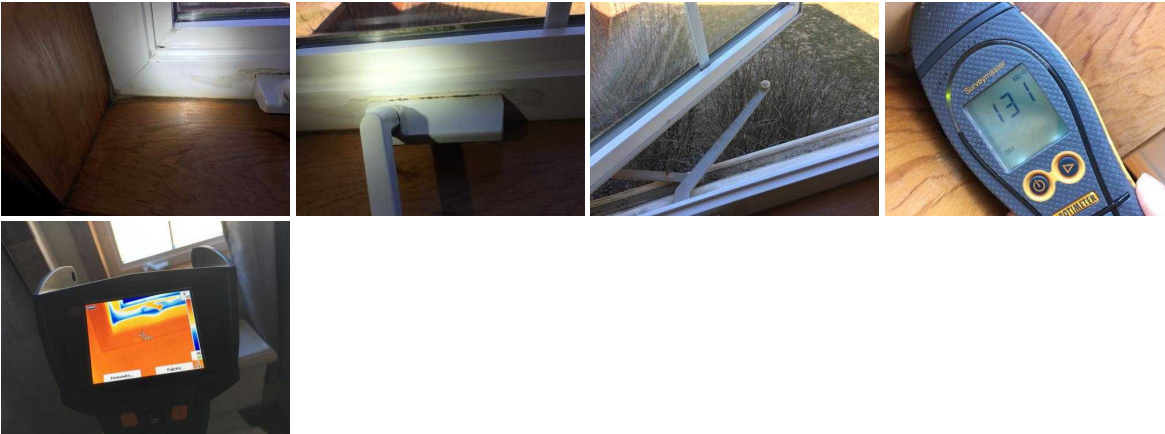
22. All Bathroom Windows: Vinyl casement - [Staining noted on trim. Tested within acceptable ranges. Arm was loose.](#)

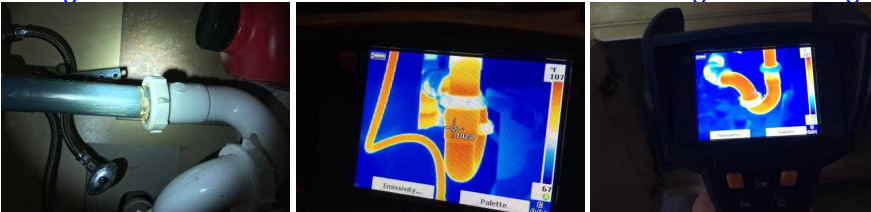
23. All Bathroom Faucets/Traps: Delta fixtures with a PVC trap - [Right master drain is showing signs of past leaking. No active leak observed. Recommend cleaning and adding new plumbers putty to threads.](#)

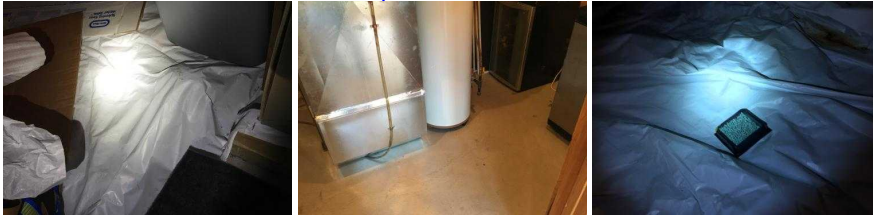
24. Main (Unfinished Areas) Basement Floor: Poured and vapor barrier covered gravel. - [Mouse poison noted. Recommend seller remove all poison hidden.](#)

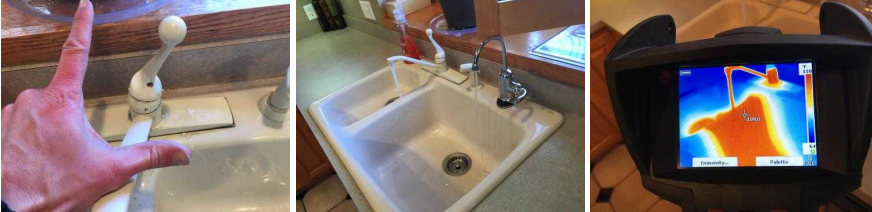
1. 1st Floor Kitchen Sink: Stainless Steel - **Faucet head leaks in rear position.**

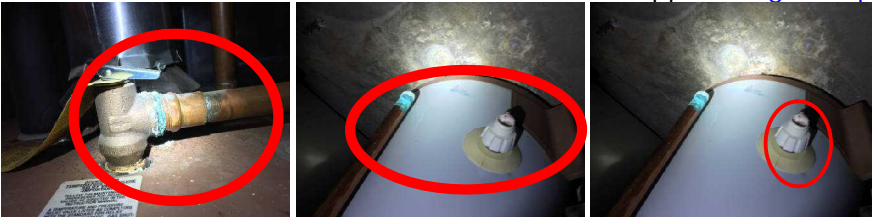
2. Basement Water Heater TPRV and Drain Tube: Copper - **signs of past leaking. drain is leaking**
